Evaluación del impacto de la infraestructura física educativa en la educación

Evaluation of the impact of the Physical Educational Infrastructure in education

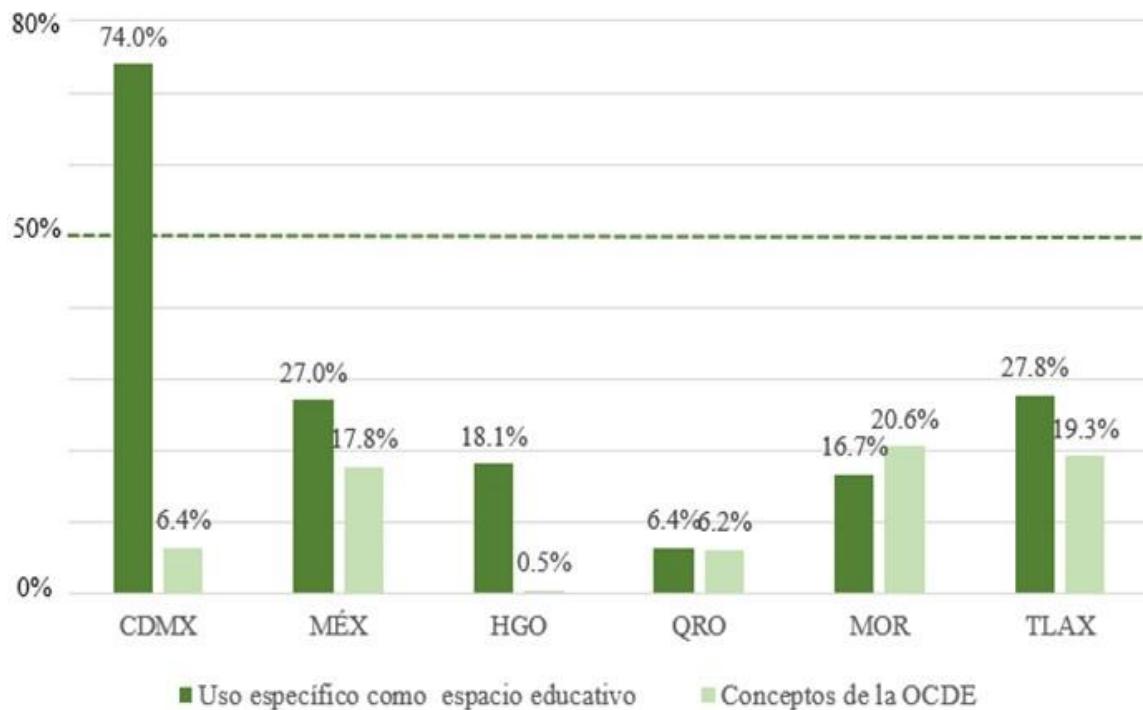
Based on the data obtained in stages I and II of the study, Figure 1 shows that Mexico City is the only entity in which, on average, 74% of the specific use of the property is met as an educational building, although only with 6.4% according to the concepts of the OECD, which refer to the basic and necessary sufficiency of the property to be able to teach classes. That is, no property evaluated in the other entities achieved compliance and only in the state of Morelos was the highest value obtained with 20.6%. It should be noted that the LGE establishes (in its article 99) that furniture and real estate must meet the requirements of "quality, safety, functionality, timeliness, equity, sustainability, resilience, relevance, integrity, accessibility, inclusiveness and hygiene." For this reason, for its evaluation in this area, three priority dimensions were defined, which each school must fulfill as an essential part of the right to education: basic services on campus, sufficient and accessible school spaces, and basic safety and hygiene conditions. However, as can be seen in figure 1, its compliance was null and no plant evaluated in this ruble reached the average mean.

Figura 1. Porcentaje de cumplimiento normativo del inmueble como espacio educativo
según los conceptos que señala la OCDE

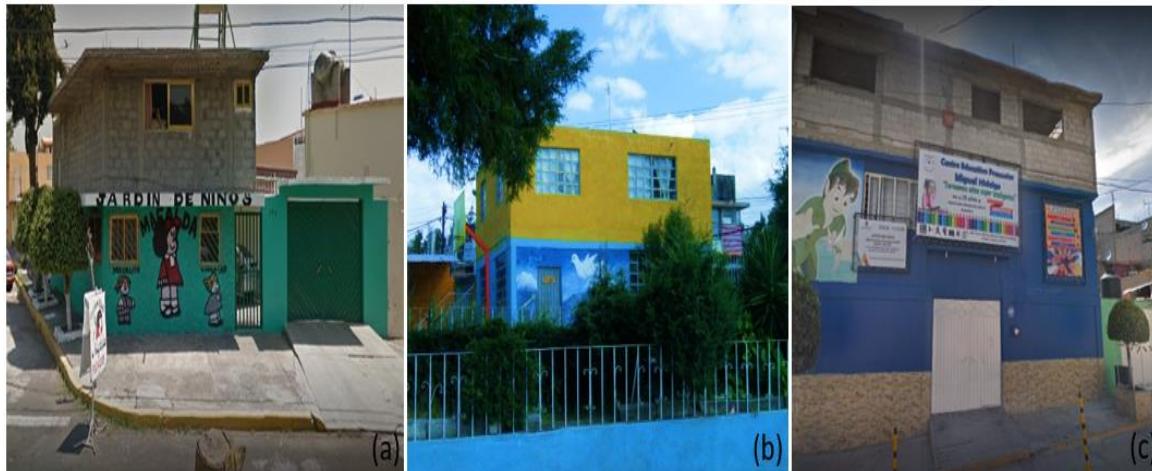
As for the executive project of the schools, this must be the representation or graphic expression of the solution to the requirements provided by the area in charge of the educational planning of the SEP and, where appropriate, it will consist of the following plans: plant of the whole or master plan, general plans of the buildings, facades and general cuts, modification plans and of all the facilities. However, the results indicate that only the states of Morelos and Tlaxcala reached 54.1% and 51.6% of regulatory compliance, respectively, which led us to ask ourselves the following question: was the campus originally designed for this purpose or was it adapted? since none presented any evidence about their planning, design, etc. In addition to this, there were some cases where various interventions were made to the facilities without having any project or record of it.

This has an impact on student learning because they spend many hours in a place that does not have the basic conditions for this purpose. In support of the aforementioned, figures 2 and 3 are shown.

Figura 2. Evidencia de construcciones con diseño habitacional que funcionan como planteles educativos (jardín de niños)

Fuente: Fotografía de Nancy Pacheco. (a) Estado de Tlaxcala de Xicoténcatl (2018), (b) Estado de Querétaro, municipio Arroyo Seco (2018) y (c) Ciudad de México, municipio Miguel Hidalgo (2018).

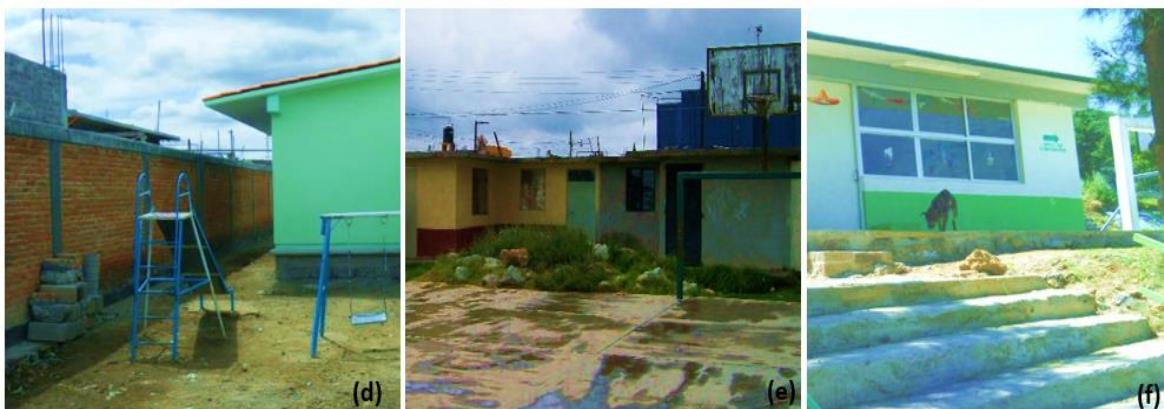
Figura 3. Evidencia de construcciones de espacios exteriores inadecuados para operar como escuelas, con cuartos construidos como anexos y fuera de la norma, así como inadecuada planeación de las aulas y de acceso a ellas

Fuente: Fotografía de Nancy Pacheco. (d) Estado de Hidalgo Pachuca del Soto (2019), (e) Estado de Morelos, municipio de Cuautla (2019) y (f) Estado de México, municipio de Valle de Cahalco (2019)

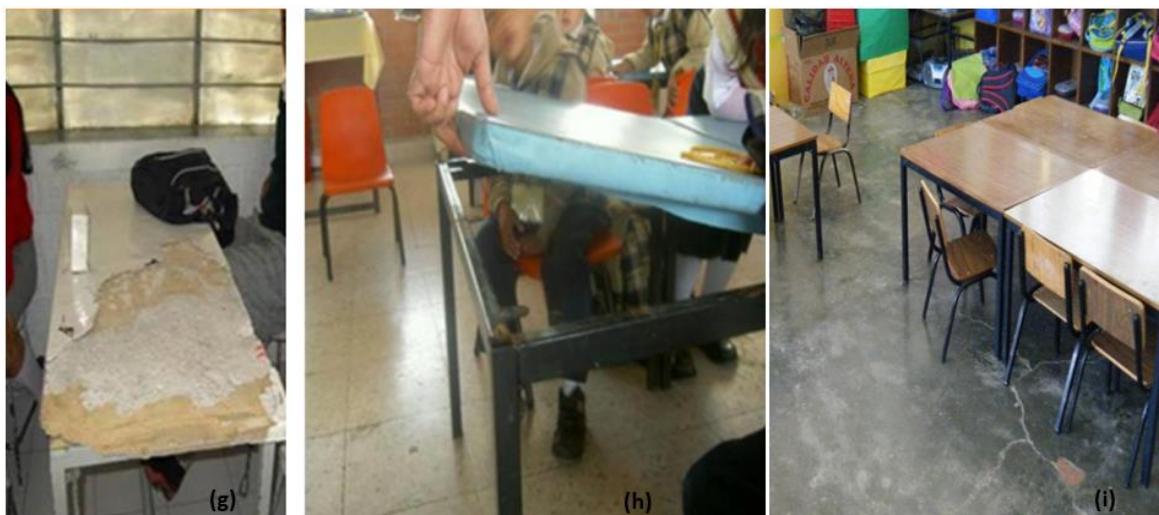
school furniture will be used by hundreds of students over a long period. For this reason, their quality must be sought so that they have an adequate duration and are safe. Likewise, in the evaluation it was considered that the furniture should be chosen according to the age of the students, the size of the classrooms and the number of students, since it is important that the children are in an environment adapted to their body measurements (ergometry and disabilities) (figure 4).

Figura 4. Mobiliario fuera de la norma para el nivel escolar, con material frágil, nulo mantenimiento y cantidad de mobiliario inadecuado

Fuente: Fotografía de Nancy Pacheco. (g) Estado de Hidalgo, municipio de Atapexco (2019), (h) Ciudad de México, municipio de Xochimilco (2019), (i) Estado de México, municipio de Ecatepec (2019)

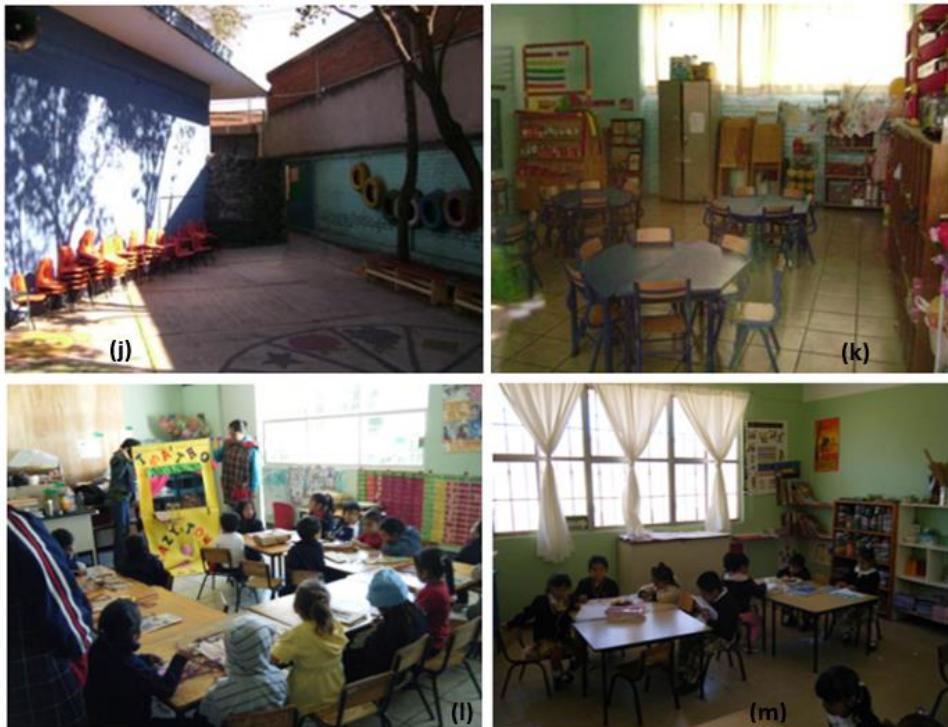
Regarding maintenance, the results showed that no campus complied with regulations and that the highest values were achieved, on average, in the State of Mexico and in Mexico City with 10.4% and 5.11%, respectively. These figures are worrying because the maintenance of the facilities and the materials used is essential to avoid accidents (figure 5).

Figura 5. Áreas de casas adaptadas para funcionar como espacios educativos, carentes de cumplimiento normativo en iluminación, ventilación, mobiliario y áreas comunes para impartir clases a nivel de educación preescolar

Fuente: Fotografía de Nancy Pacheco. (j) Estado de Querétaro, municipio de Tolimán (2018), (k) Estado de Morelos, municipio de Yautepec (2019), (l) Estado de Tlaxcala, municipio Zacatelco (2019), (m) Estado de Hidalgo, Tolcayuca (2018).

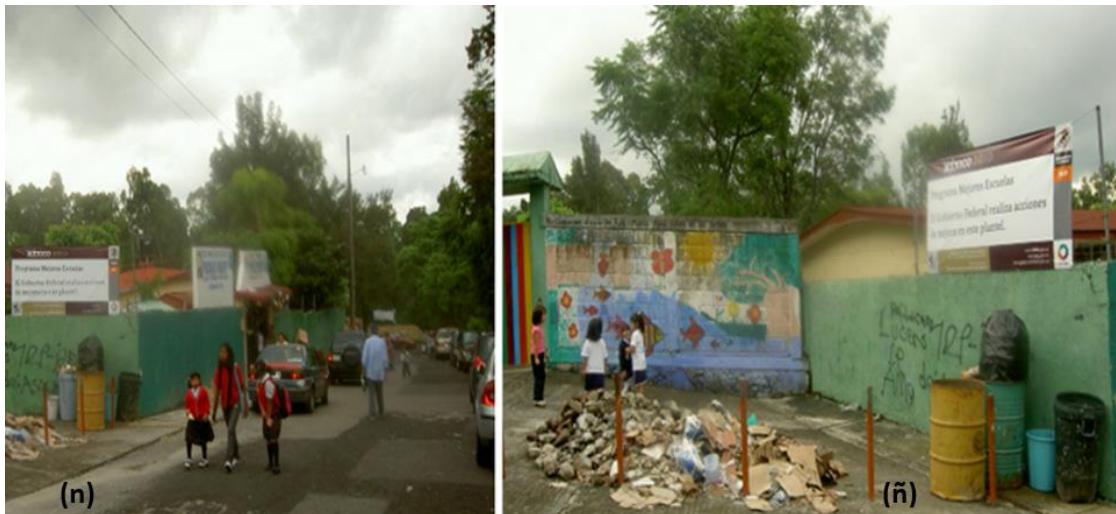
Likewise, regarding the result of the situation of the environment (geographical environment) where the evaluated buildings are located, only the state of Hidalgo presents on average a maximum value of 55.1% compliance. In this regard, it is worth underlining that this environmental factor is of vital importance for the development of the education of the students, since in the surroundings of the schools evidence of risk or contamination areas was found (eg, gas stations, markets, garbage dumps, high voltage lines, rapid primary roads and bus terminals within a kilometer) (figure 6).

Figura 6. Planteles educativos que colindan en sus espacios exteriores con vías primarias sin protección ni señalización alguna (para los menores que transitan diariamente), así como con basureros a cielo abierto perjudiciales para la salud (transmisión de enfermedades infecciosas)

Fuente: Fotografía de Nancy Pacheco. (n) Estado de Tlaxcala, municipio de Apizaco (2019), (ñ) Estado de Hidalgo, municipio de Chilcuautla (2019)

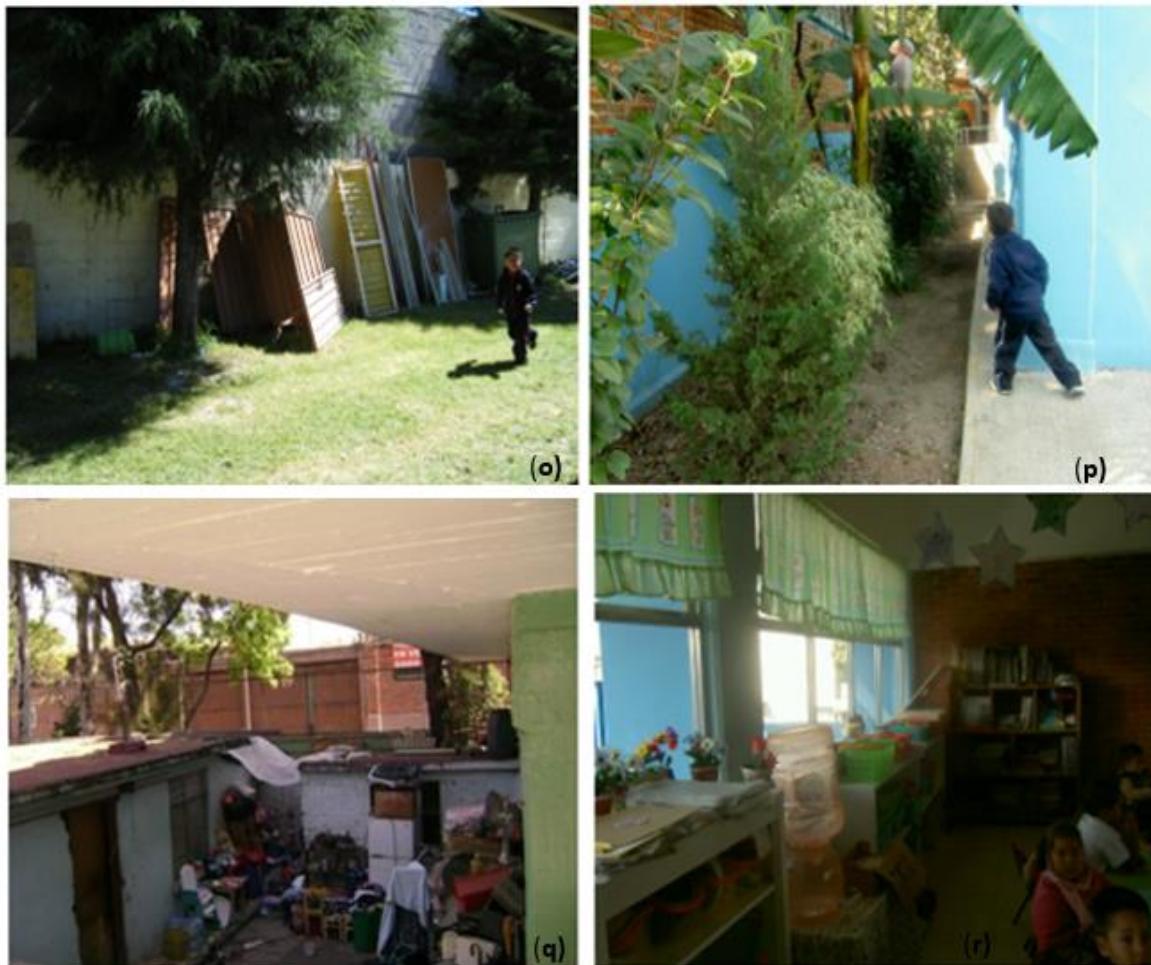
Figura 7. Áreas interiores de las casas adaptadas como planteles educativos que colindan con otras casas usadas como bodegas, cocinas, etc.

Fuente: Fotografía de Nancy Pacheco. (o) Estado de México, municipio de Atizapán Zaragoza (2019), (p) Ciudad de México, municipio Azcapotzalco (2019), (q) Estado de Hidalgo, municipio de Lerma y (r) Estado de Querétaro, municipio de Huimilpan

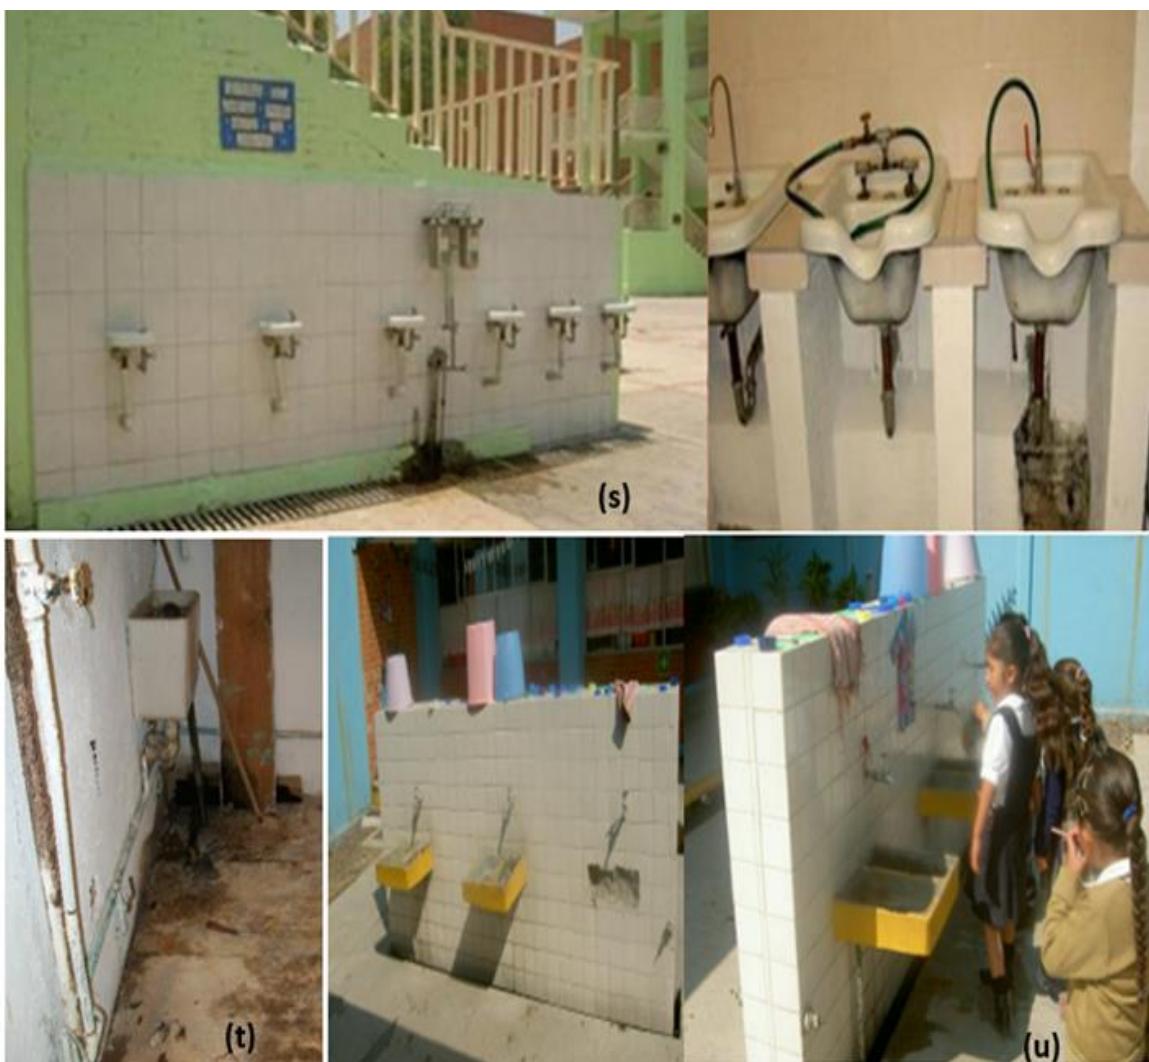
Figura 8. Instalaciones hidrosanitarias en mal estado y ambiente carente de higiene

Fuente: Fotografía de Nancy Pacheco. (s) Estado de Querétaro, municipio de Tolimán (2019), (t) Ciudad de México, municipio Azcapotzalco (2019), (u) Estado de México, municipio de Coacalco de Berriozábal

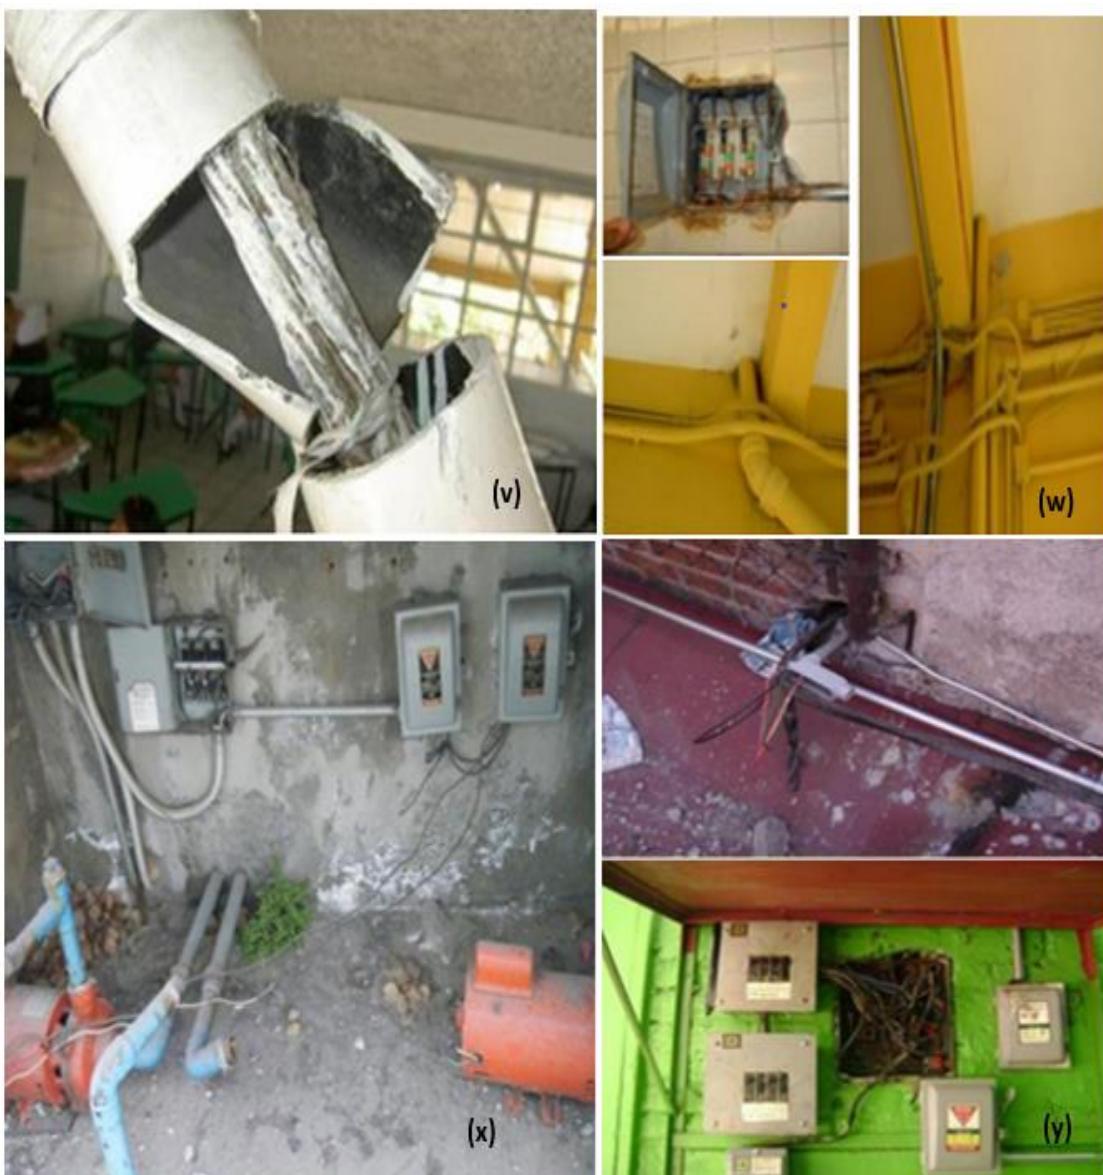
Figura 9. Nulo mantenimiento eléctrico en las instalaciones

Fuente: Fotografía de Nancy Pacheco. (v) Estado de Querétaro, municipio de Huilmán (2019), (w) Ciudad de México, municipio Tláhuac (2019), (x) Estado de México, municipio de Acolman, (y) Estado de Tlaxcala municipio de Ixtenco
