Seguimiento al análisis de las edificaciones de uso escolar: su evaluación e impacto en la educación primaria y secundaria

Follow-up to the analysis of buildings for school use: their evaluation and impact on primary and secondary education

Nancy Jacqueline Pacheco Martínez

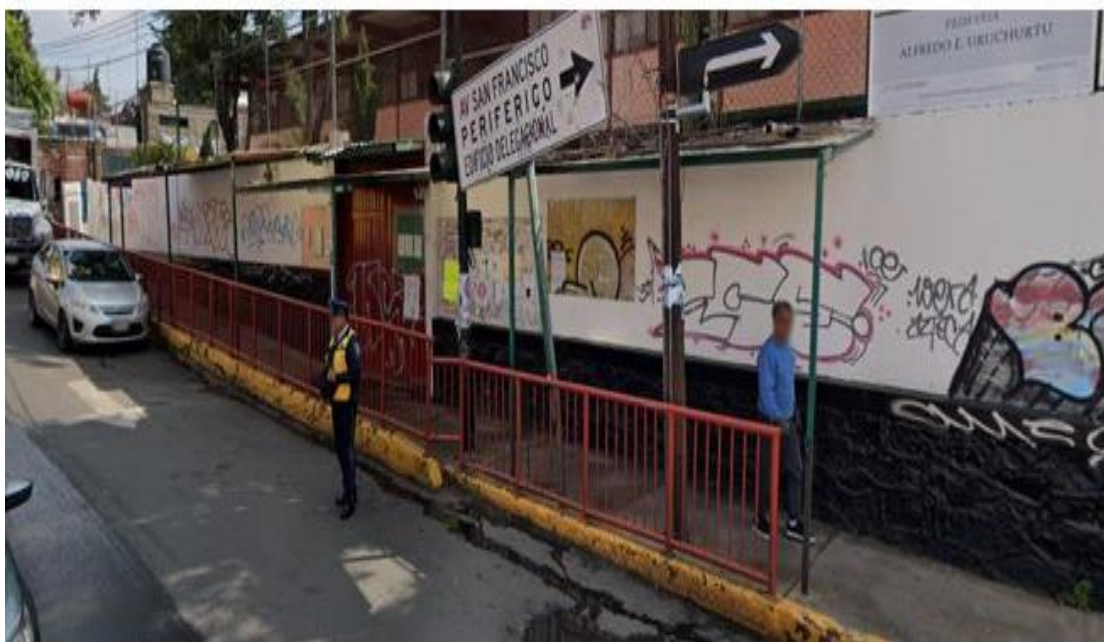
Figura 4. Escuela secundaria ubicada en Ciudad de México, en la localidad de Tláhuac. Obsérvese que se desaprovecha la luz y la ventilación debido a las rejas agregadas por inseguridad o por estar ubicada frente a vías rápidas de transporte.

In this sense, the results obtained present serious deficiencies, since there are no longer large windows to take advantage of natural light and ventilation. Instead, fences have now been erected due to insecurity, obstructed with artificial elements from the environment, or removed to expand other adjoining areas required by the large number of students. In addition, some of these windows border garbage cans, house walls, expressways, gas stations or vandalism areas; see (figures 4 and 5).

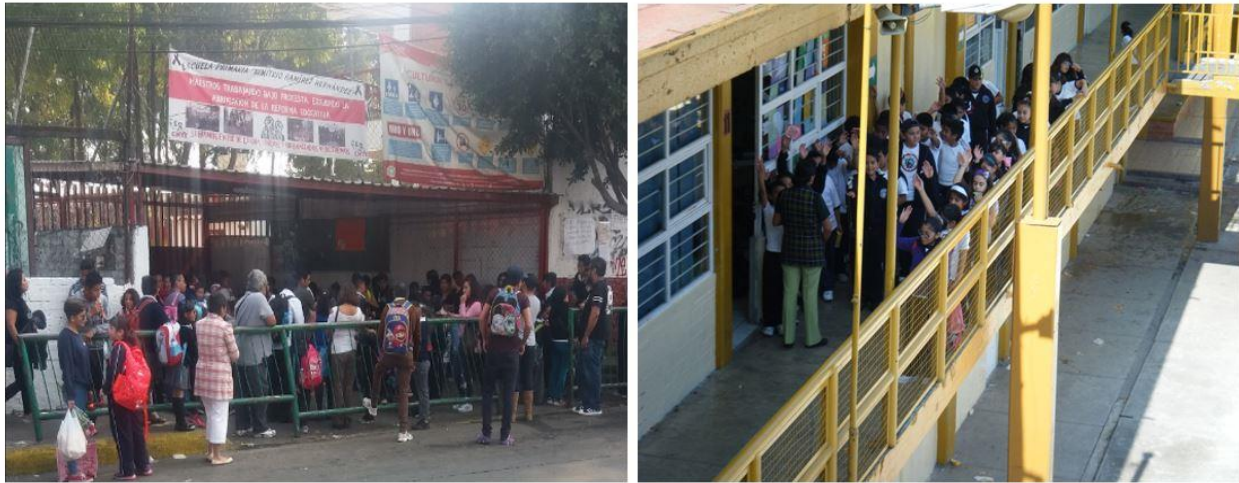
Figura 10. Primaria ubicada en la Ciudad de México, municipio de Magdalena Contreras. Se evidencia la demanda de alumnos, así como la carencia de docentes en los niveles básicos de educación.

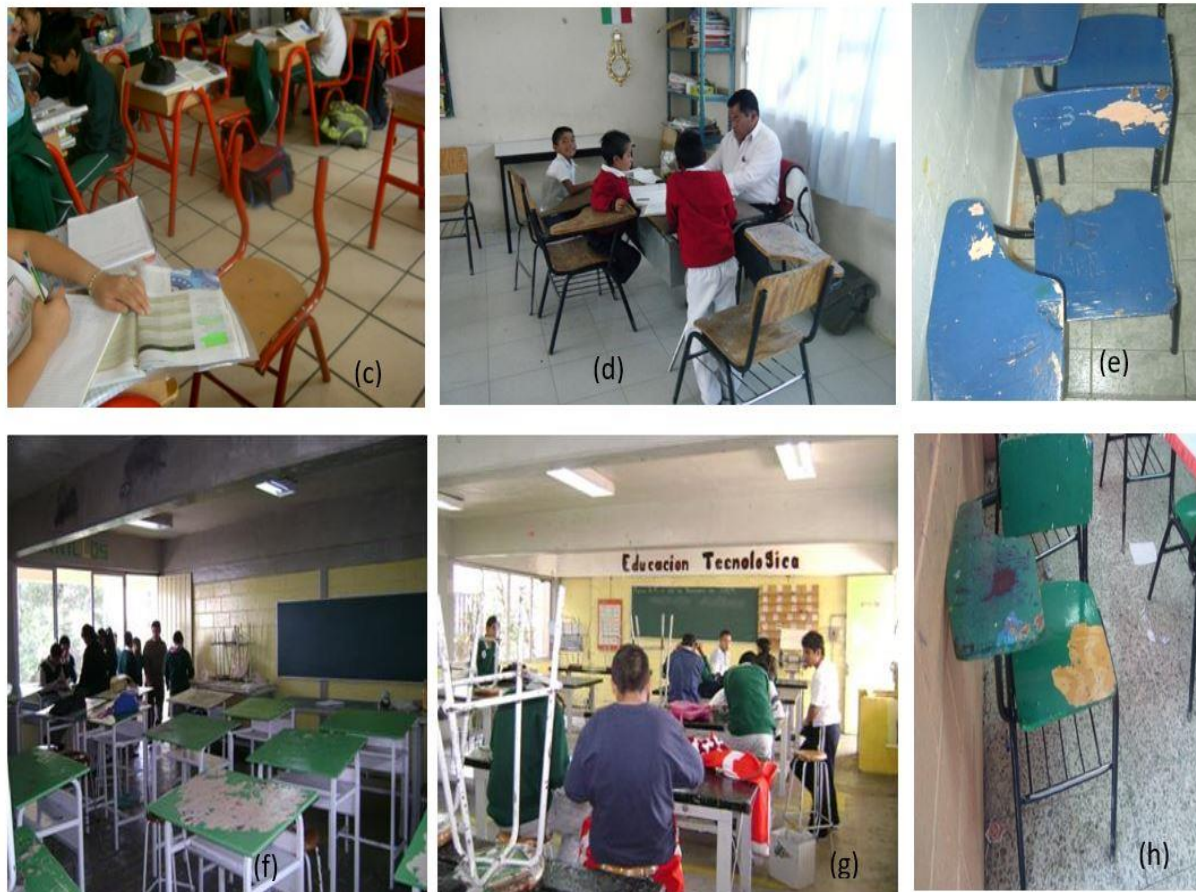
Figura 13. Estado actual del mobiliario de las escuelas evaluadas tanto a nivel primaria como secundaria en los estados de Hidalgo (c), Ciudad de México (d, e, f) y Tlaxcala (g, h).

Figure 13 showed - in image (c) - backless chairs that can cause accidents and make it impossible to carry out activities properly; In the image (d) it can be seen that the chairs are larger than the students - out of the norm for the level and without maintenance (e) and (h) -. Also, without light in basic areas (such as workshops) and without adequate equipment for laboratories (g).

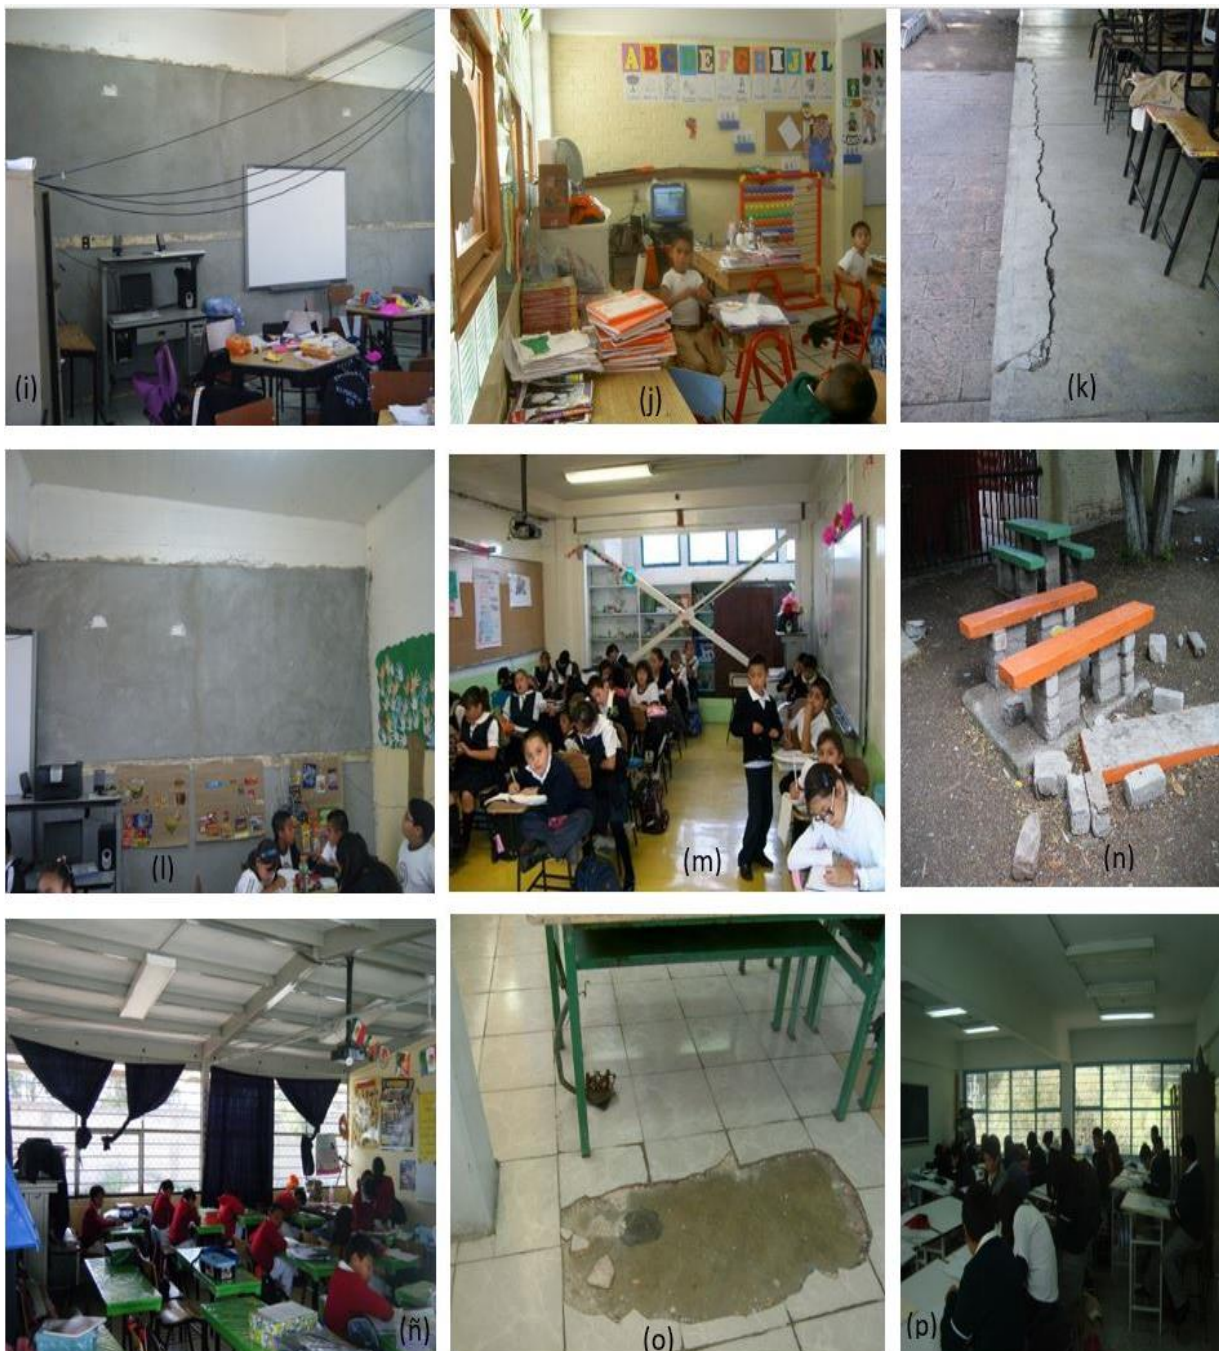
Figure 15 shows that several of the educational establishments analyzed are residential houses with adapted areas. For example, image (i) shows the improvised electrical installations above the students' desks; Image (j) shows the area adapted without ventilation and without adequate light to carry out academic activities; Image (k) shows that the areas (classrooms) were expanded due to excess school demand, although without taking into account adequate regulatory compliance; Image (l) reflects that classes continue to be taught even when extensions of the areas are being carried out at the same time; the image (m) shows that many of the residential houses are operating as a school closing down areas of daily use, which is incorrect and unsafe for the performance of the students; Image (n) shows how they improvise and adapt the furniture for recreation areas; the image (ñ) shows the improvised roof, which is unsafe and outside the regulations; the image (o) shows the null maintenance; and the image (p) shows the lack of lighting in the basic areas where the classes are taught.

Figura 15. Condiciones de los espacios educativos para impartir clases tanto a nivel de educación primaria como secundaria. Imágenes (i), (l) y (m) de Hidalgo; imágenes (j), (ñ), (o) y (p) de la Ciudad de México; imágenes (k) y (n) de Tlaxcala.

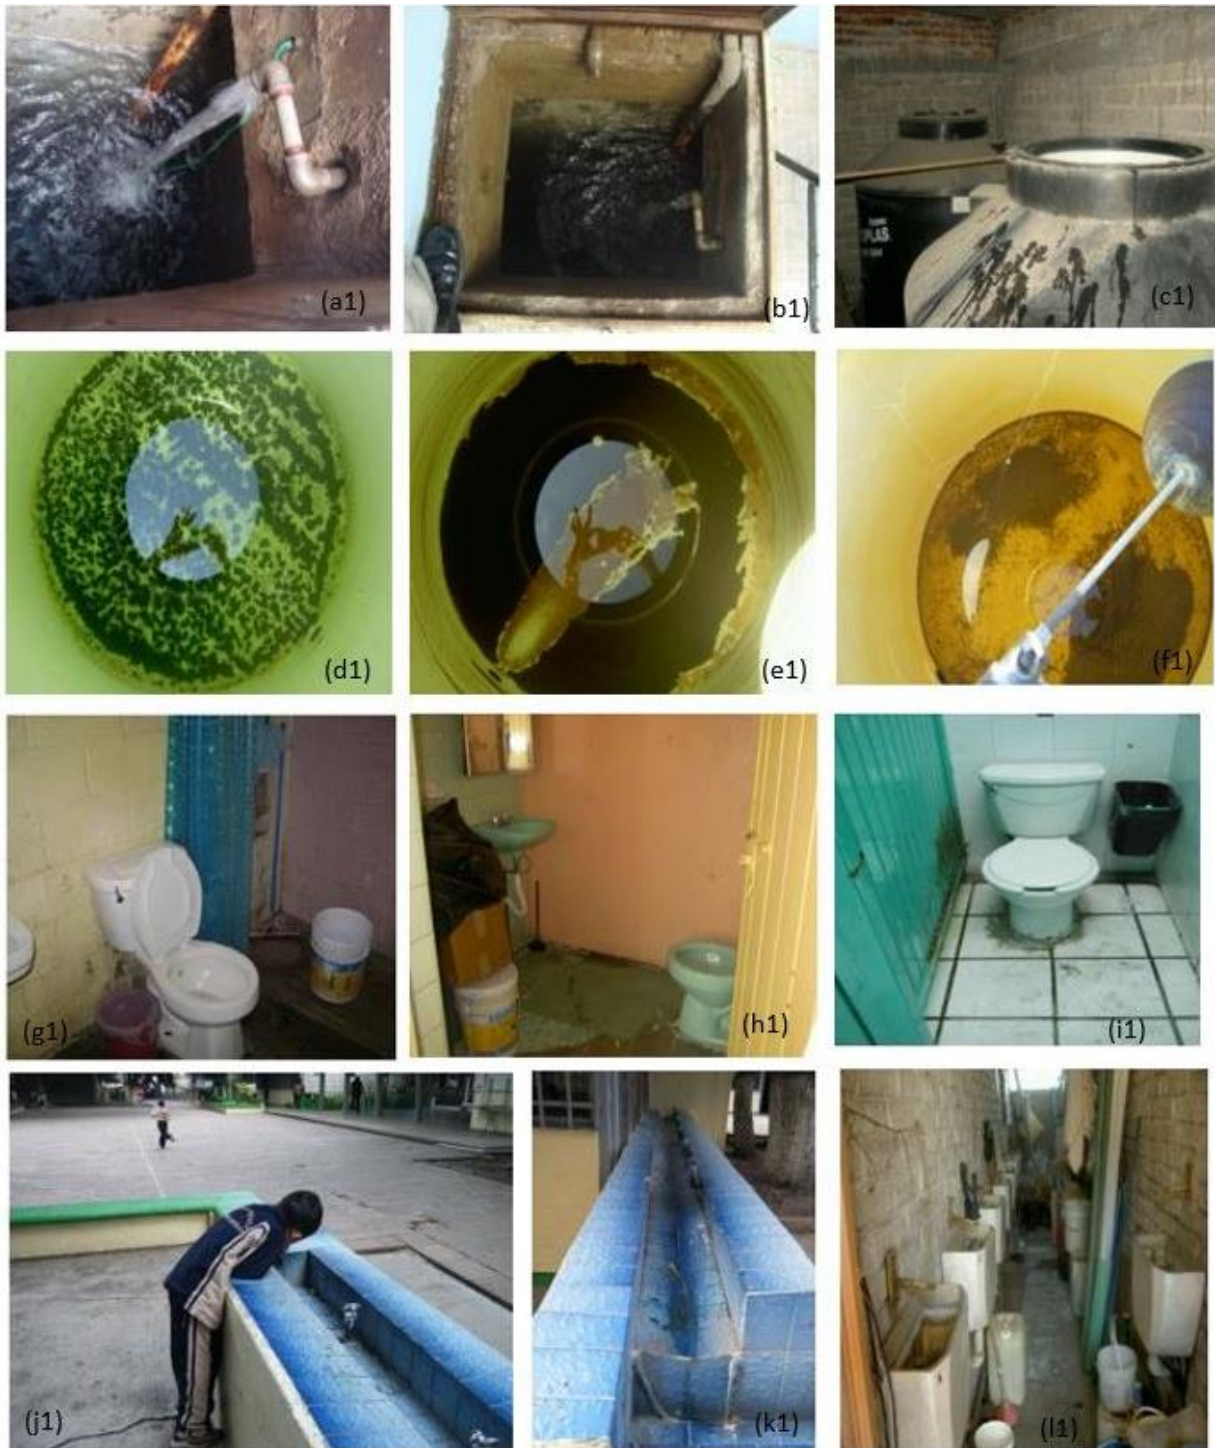
Figura 17. Instalaciones hidrosanitarias en mal estado y ambiente carente de higiene tanto en educación primaria como en secundaria. Imágenes (a1), (d1), (e1), (g1) de Hidalgo; imágenes (b1), (h1), (l1) de la Ciudad de México; e imágenes (c1), (f1), (i1), (j1), (k1) de Tlaxcala.
